High-Heat-Flux Cyclic Durability of Thermal and Environmental Barrier Coatings

**Materials Science and Technology 2007 Conference and Exhibition, Detroit, Michigan
September 18, 2007**

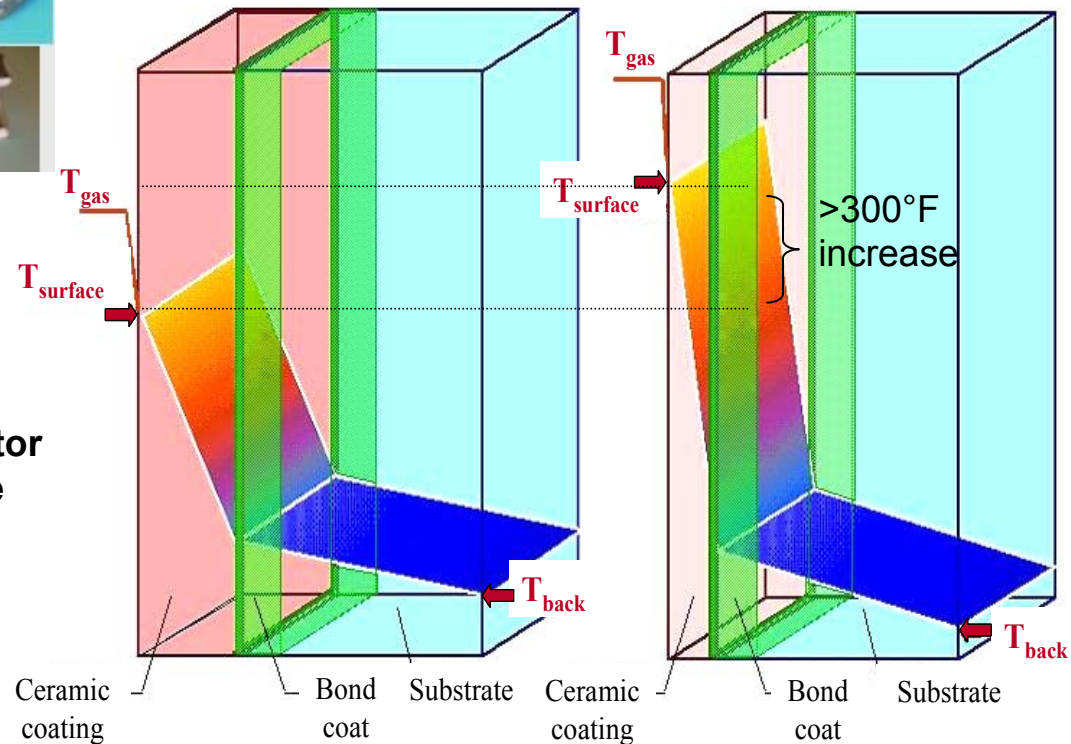
CMC combustor
liner and vane

(a) Current T/EBCs

(b) Advanced T/EBCs

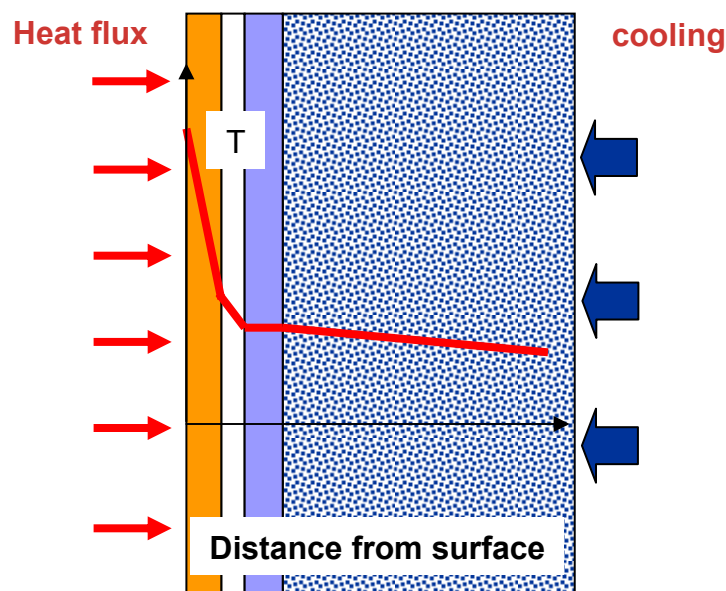
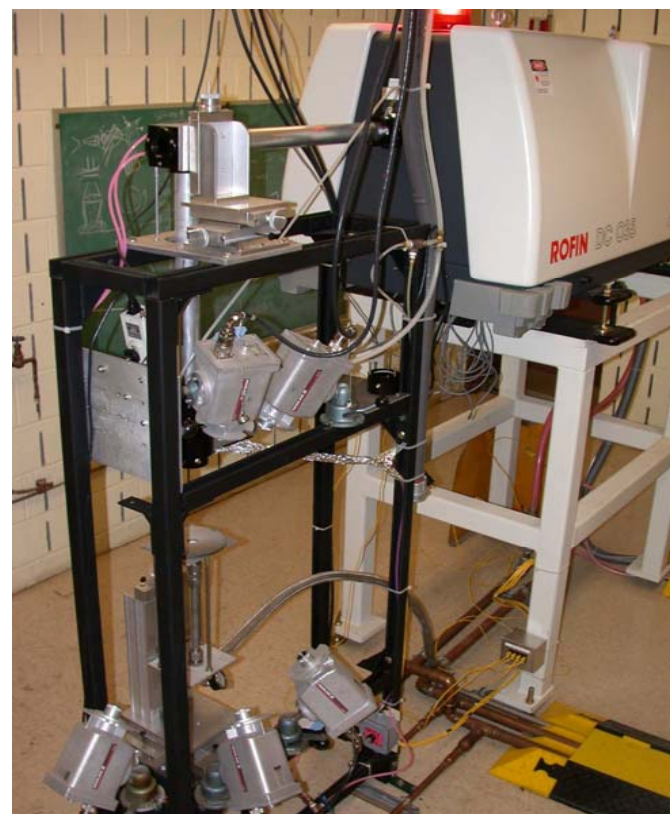
NASA CO₂ Laser Rig

— High-heat-flux laser test approach for thermal barrier coating cyclic durability

- Temperature gradient requirements: up to 200 °C/100 microns
- Heat flux requirements up to 200-300 W/cm²

Current capability up to 315 W/cm²

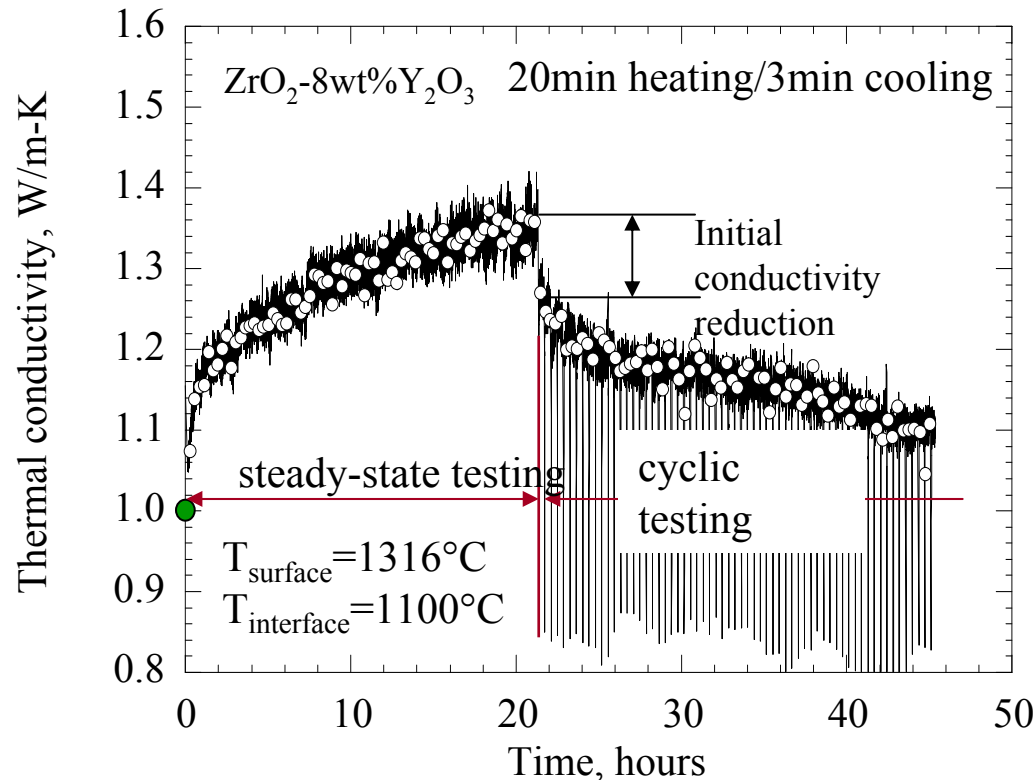
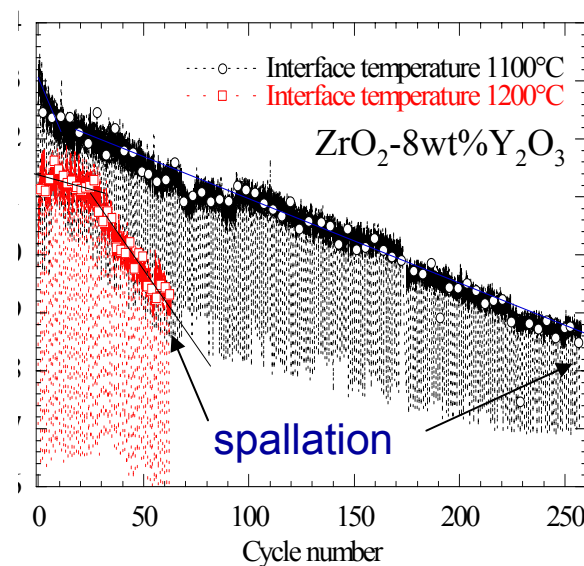
Laser Heat Flux Testing of Thermal Barrier Coatings

- Approximate constant heat flux
- Sintering induced conductivity increase during the steady-state testing
- Sintered coatings tend to have accelerated delamination under subsequent cyclic testing

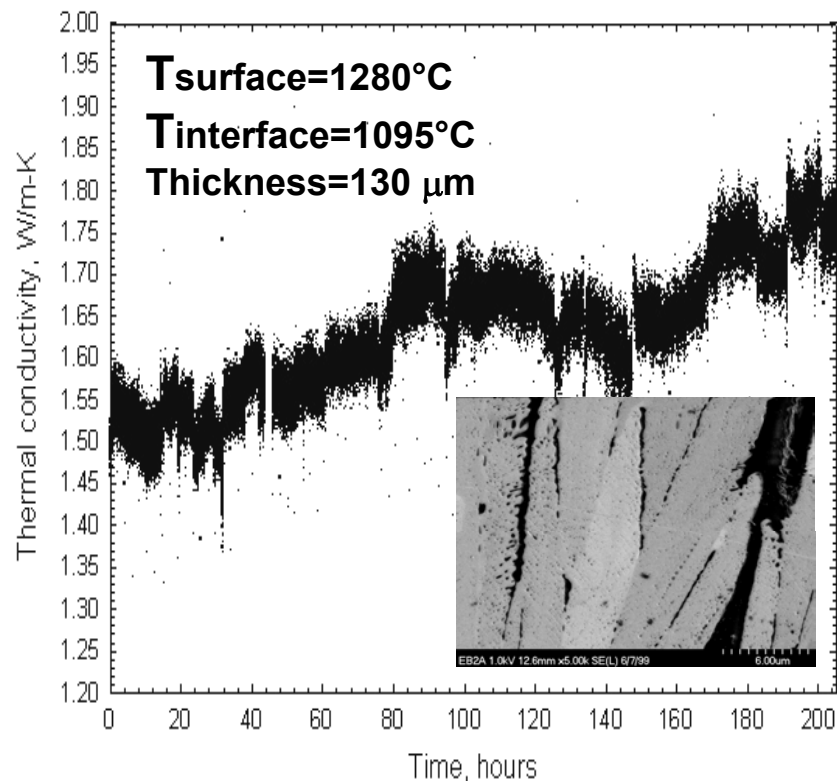
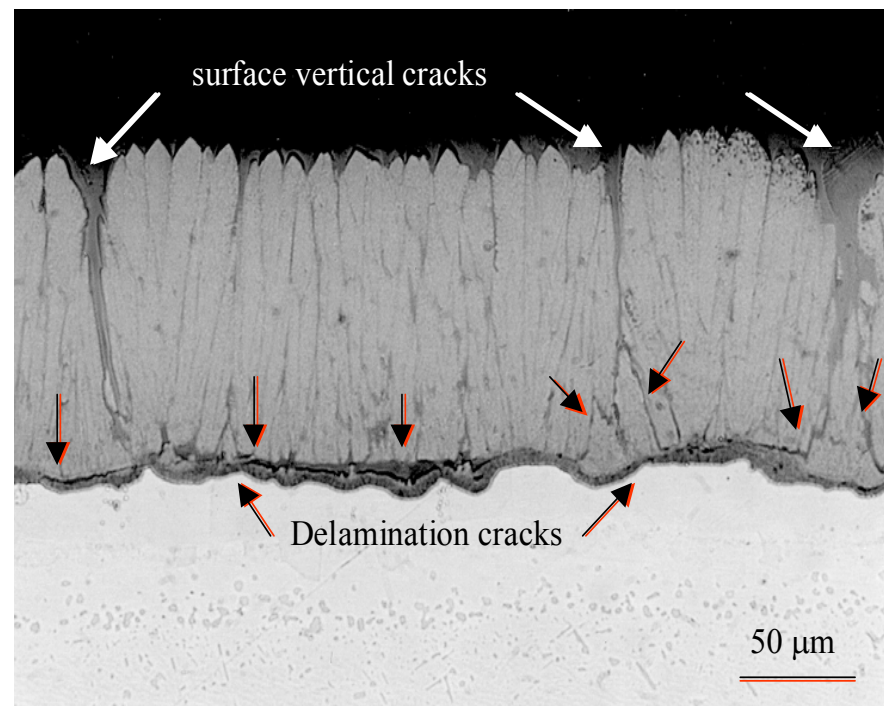
High Heat-Flux Sintering Induced Cracking and Delamination in EB-PVD ZrO_2 -7wt% Y_2O_3 Coating

- High-heat-flux surface sintering cracking and resulting coating delaminations

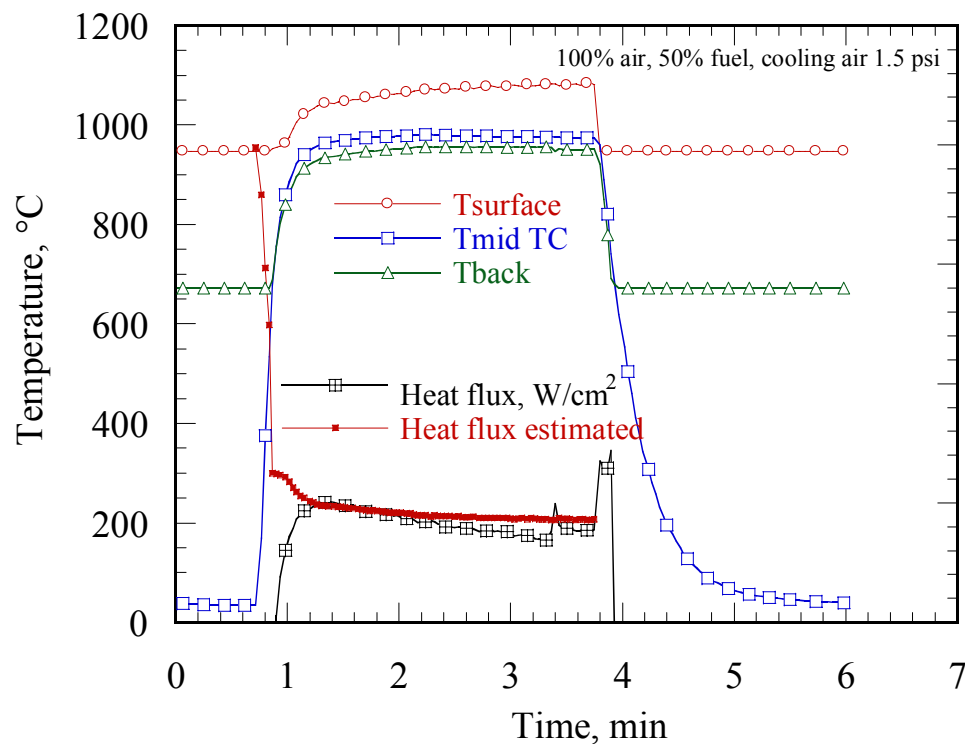
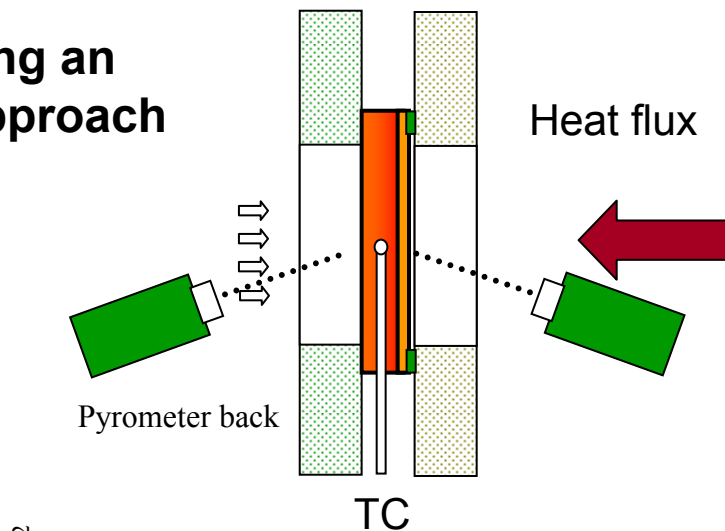
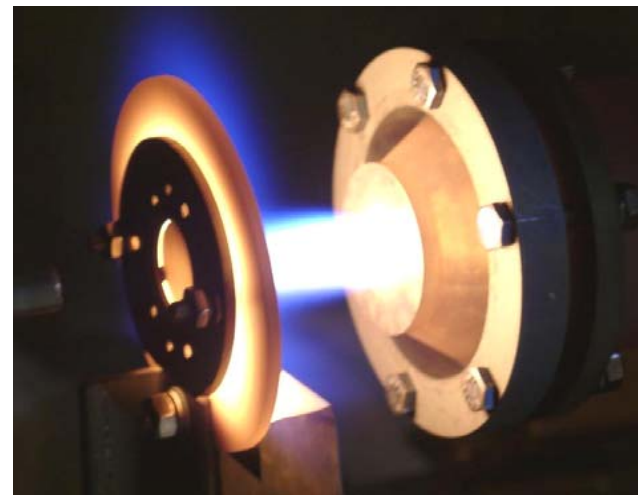
Burner Rig Heat Flux Characterization

- Burner rig heat fluxes characterized using an embedded thermocouple (TC) sensor approach
- Initial heat flux 100-200 W/cm² observed

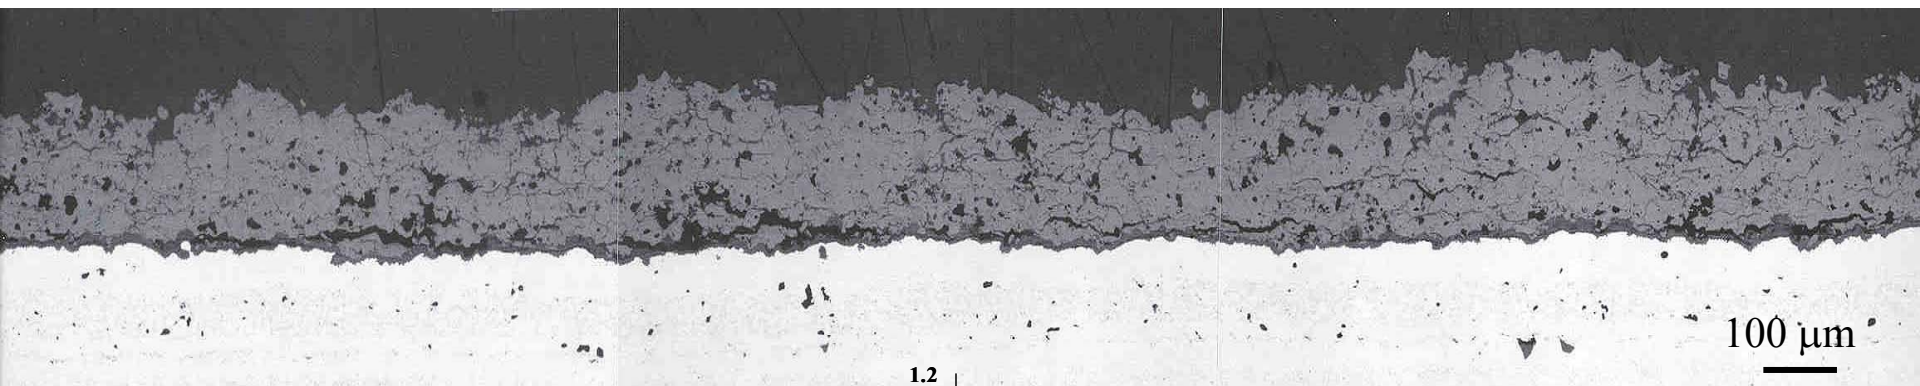
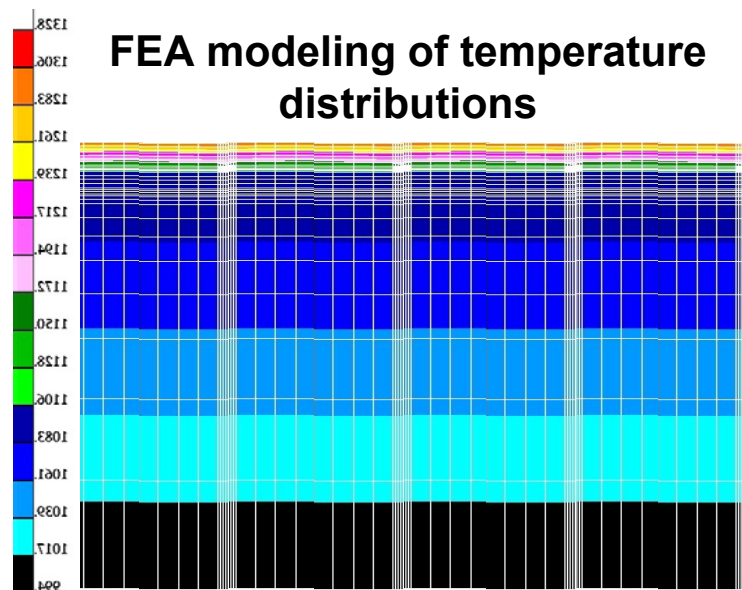
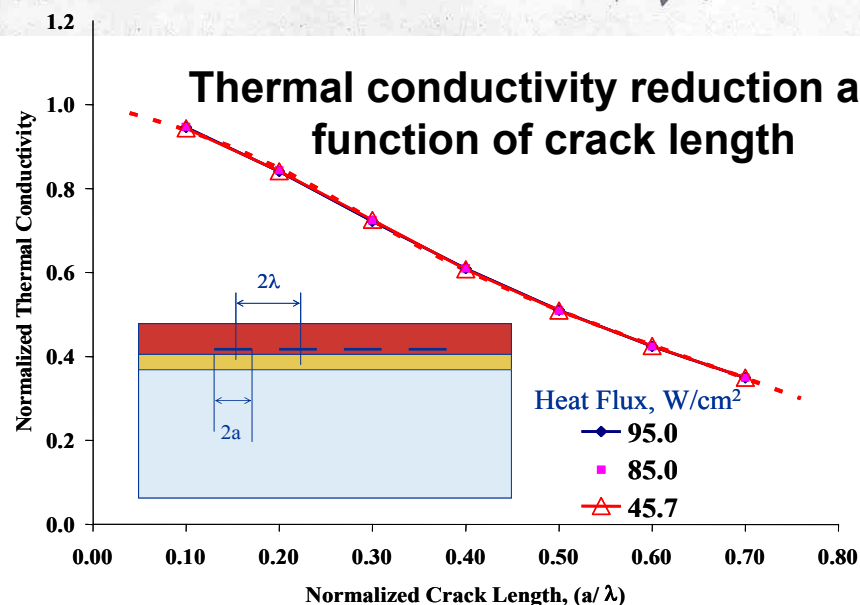
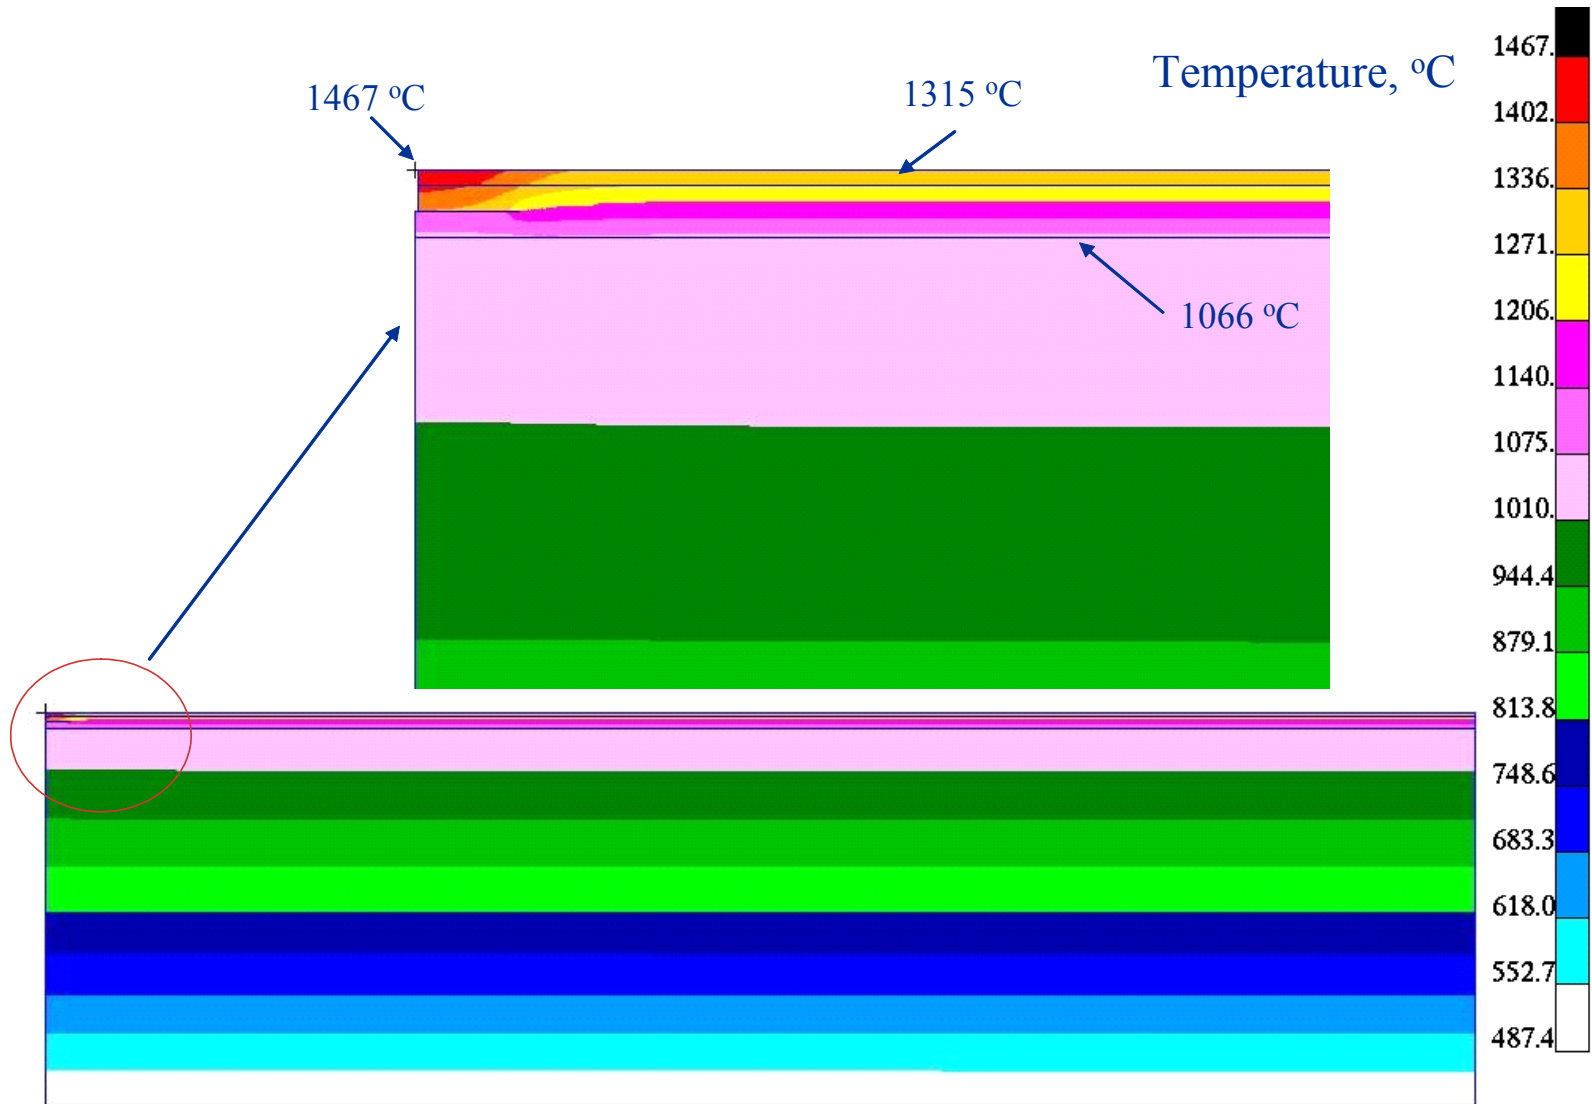
Thermal Gradient Tested TBC Delamination and Modeled TBC Delamination Induced Conductivity Reduction

- Laser tested at $T_{\text{surface}} \sim 1316^{\circ}\text{C}$ and $T_{\text{interface}} \sim 1100^{\circ}\text{C}$ under the combined steady state (22 hrs) and 20 min heating/3 min cooling cycles (256 cycles)

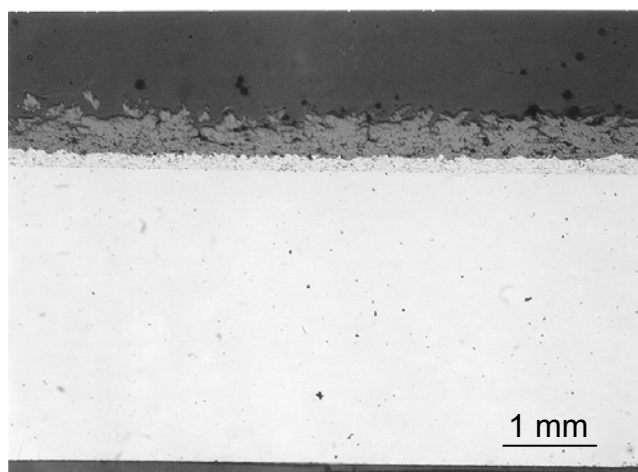
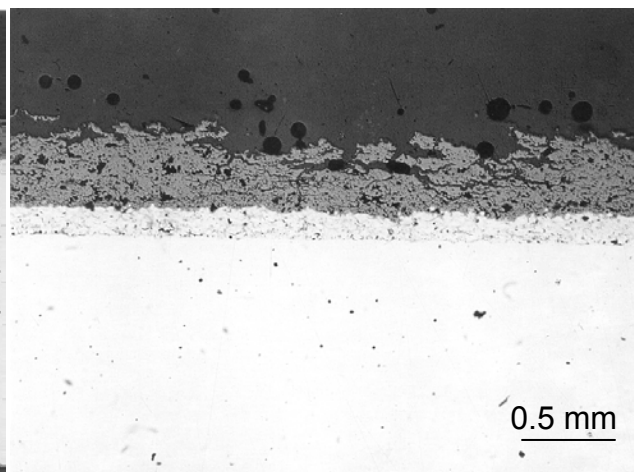
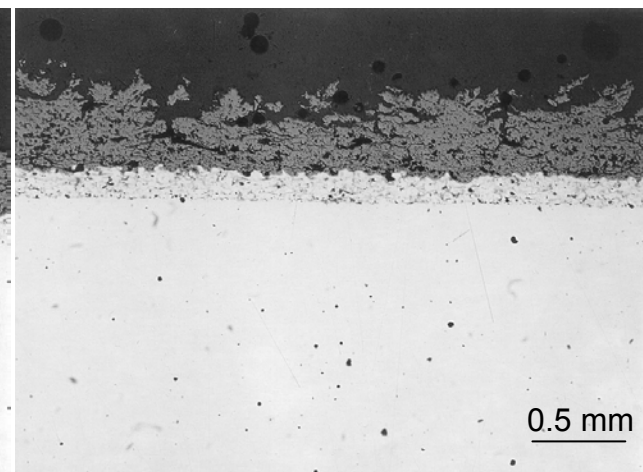
Coating Failure Modes under High Heat Fluxes and High Thermal Gradients

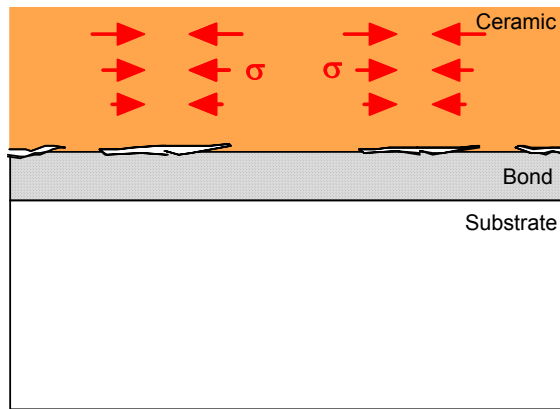
(a) Low Heat Flux and High Interface Temperature

Summary of Coating Failure Modes under Thermal Gradients

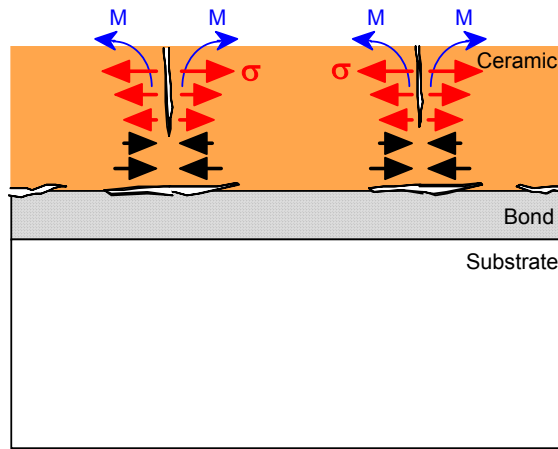
(b) Medium Heat Flux and Interface Temperature

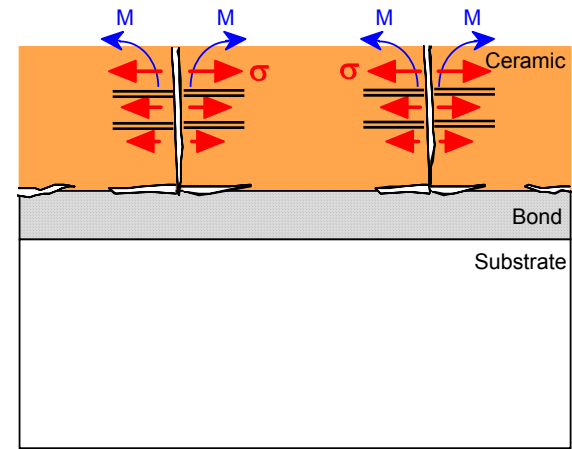
(c) High Heat Flux and Low Interface Temperature

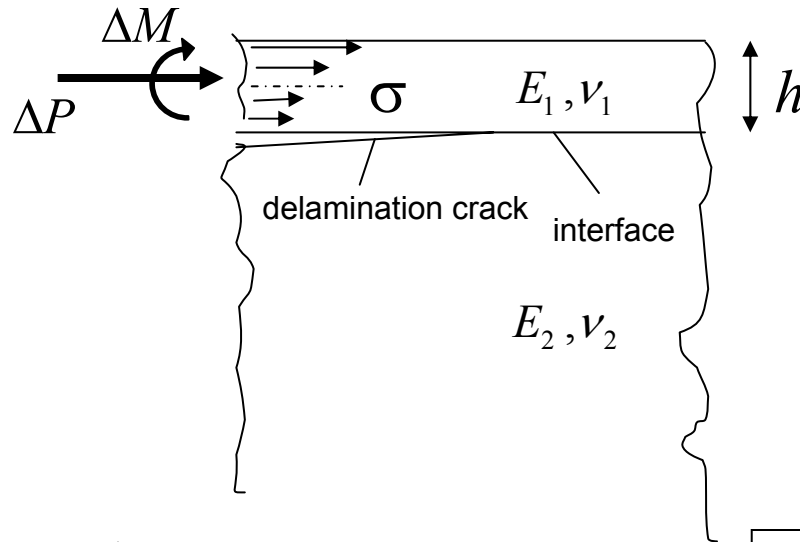
Delamination Driving Forces Correlated to Temperature Gradients and Modulus

$$G = \frac{1}{6} \left(\frac{1 + \nu_1}{1 - \nu_1} \right) E_1 h \left(\alpha_1 (T_s - T_0) \right)^2$$

Predicted delamination driving force G can be in the range of 20-80 J/m²

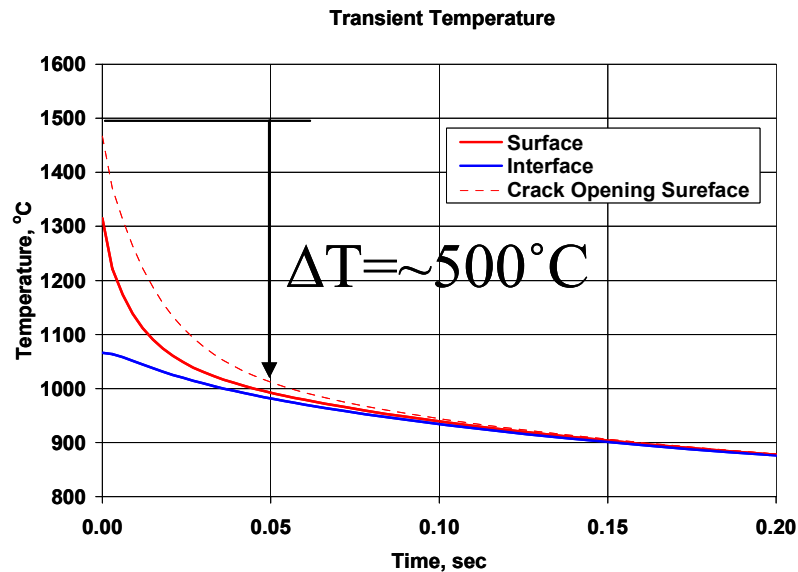
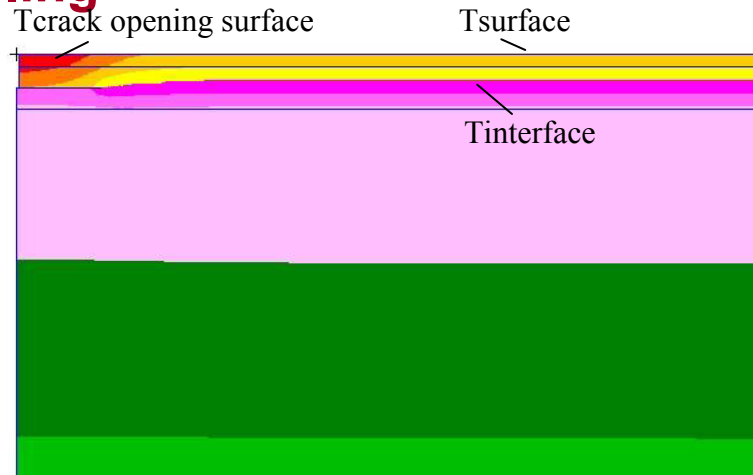
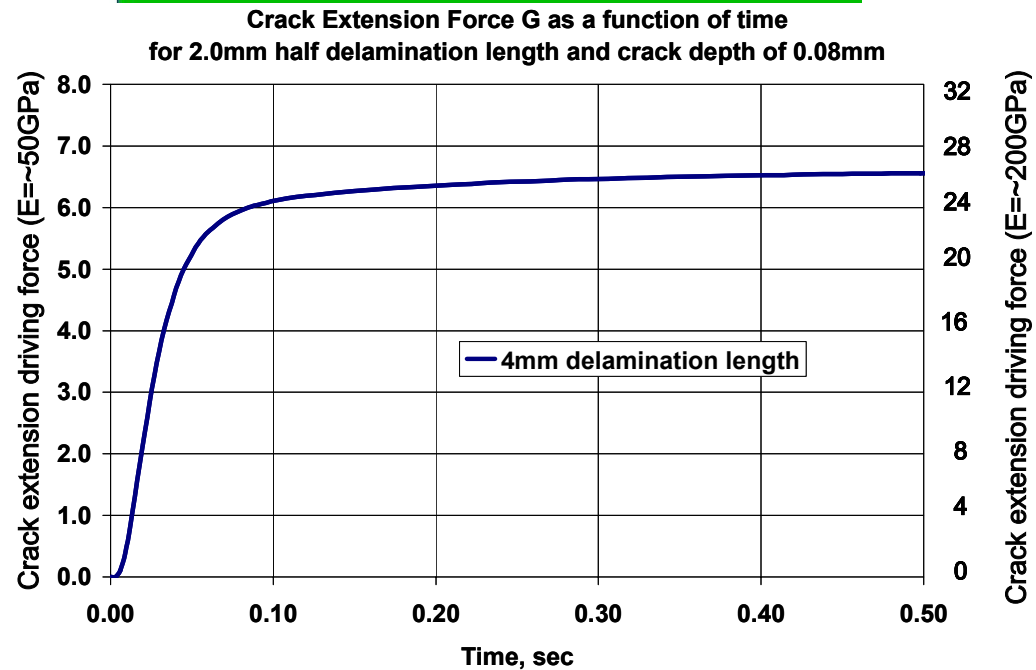
Delamination Driving Force Due to Transient Surface Cooling

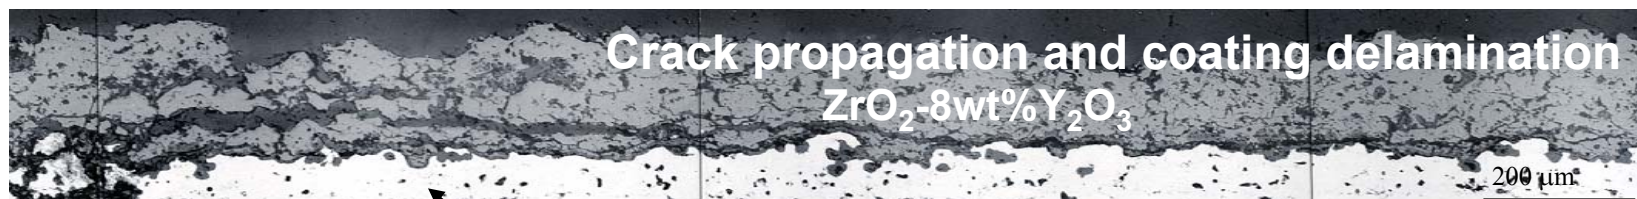
Delamination Crack Propagation observed under Heat-Flux Thermal Gradient Cyclic Condition

A center penny-shape crack propagation

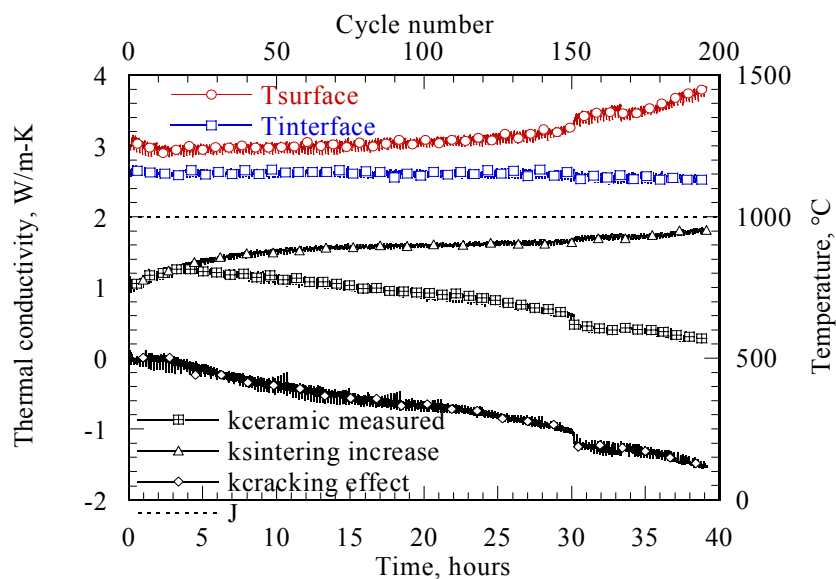
Thermal conductivity change as a function of cycle number

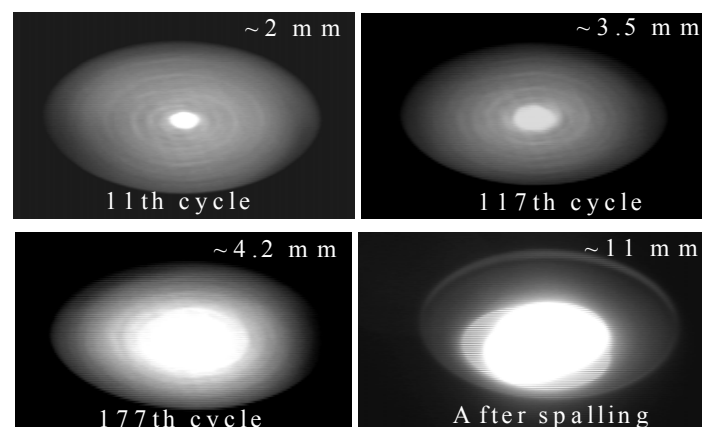
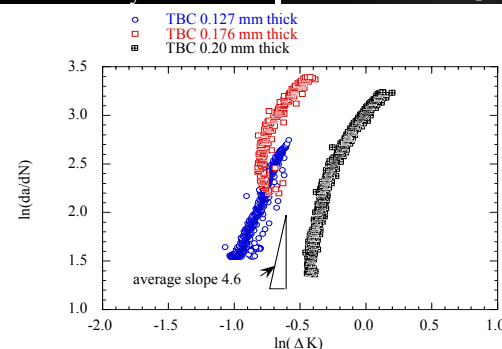
Crack propagation da/dN -stress intensity amplitude ΔK plot for life prediction

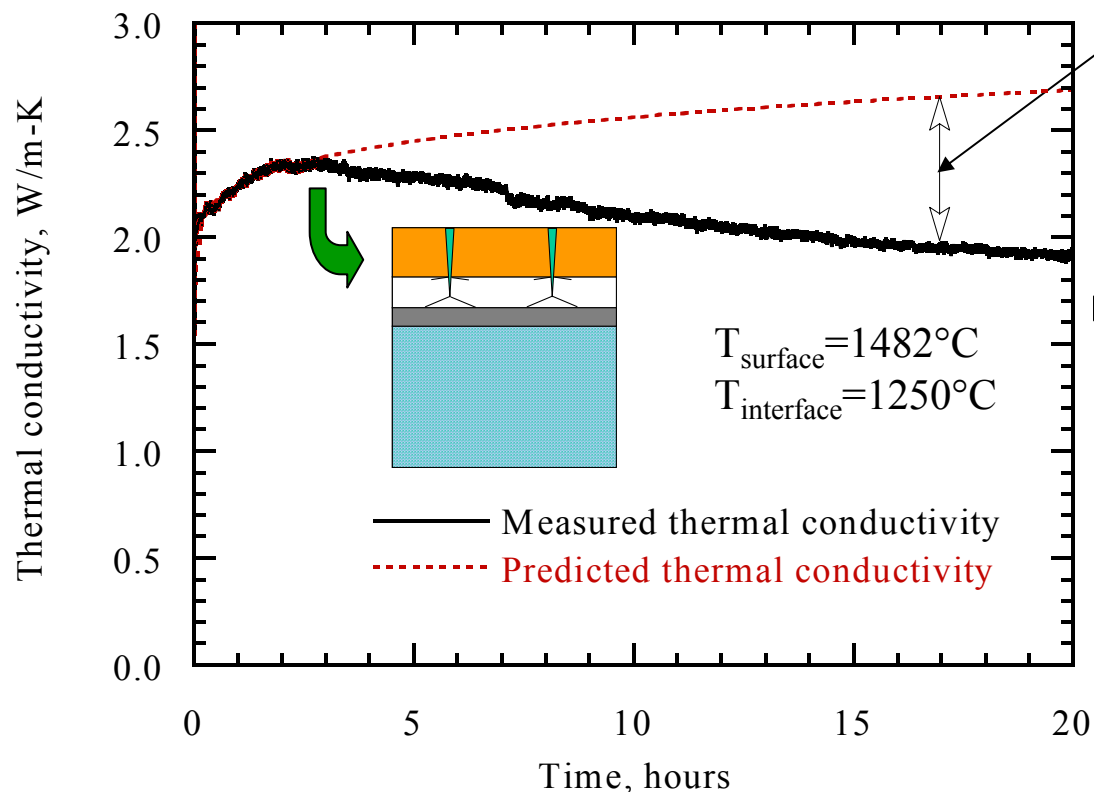
Sintering Induced Cracking in an EB-PVD ZrO_2 -7wt% Y_2O_3 Coating

- Conductivity initially increased due to sintering
- Conductivity later decreased due to coating delamination cracking resulting from the large sintering shrinkage
- * **Coating delaminates at temperature during the steady-state testing due to sintering**

Conductivity reduction due to sintering cracking induced delamination cracking

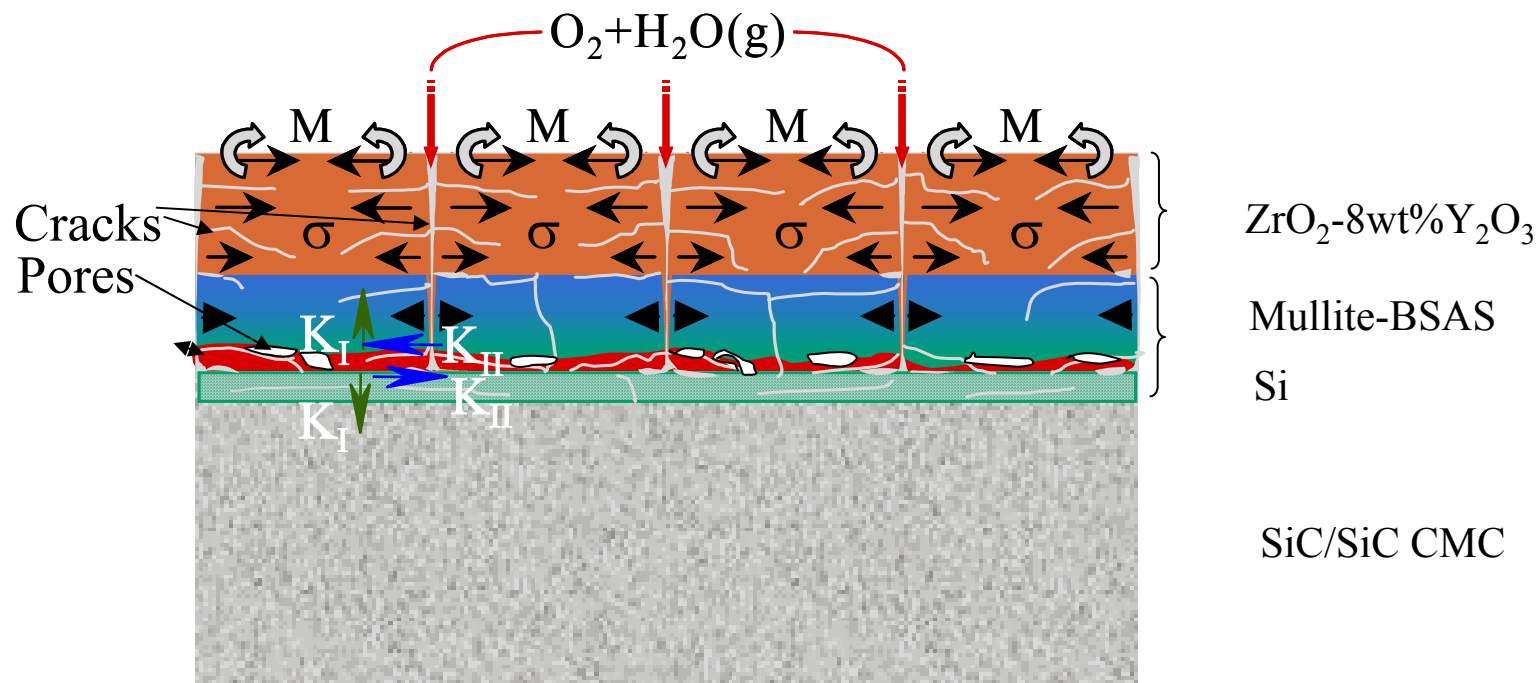
Durability Issues of Ceramic Thermal and Environmental Barrier Coating (TEBC) Systems

- Sintering and CTE mismatch induces surface wedge-shape crack propagation
- Surface cracking accelerates coating delamination under mixed mode loading (K_I and K_{II})
- Interfacial pore formation due to the chemical reactions further accelerated coating spallation under thermal gradient conditions

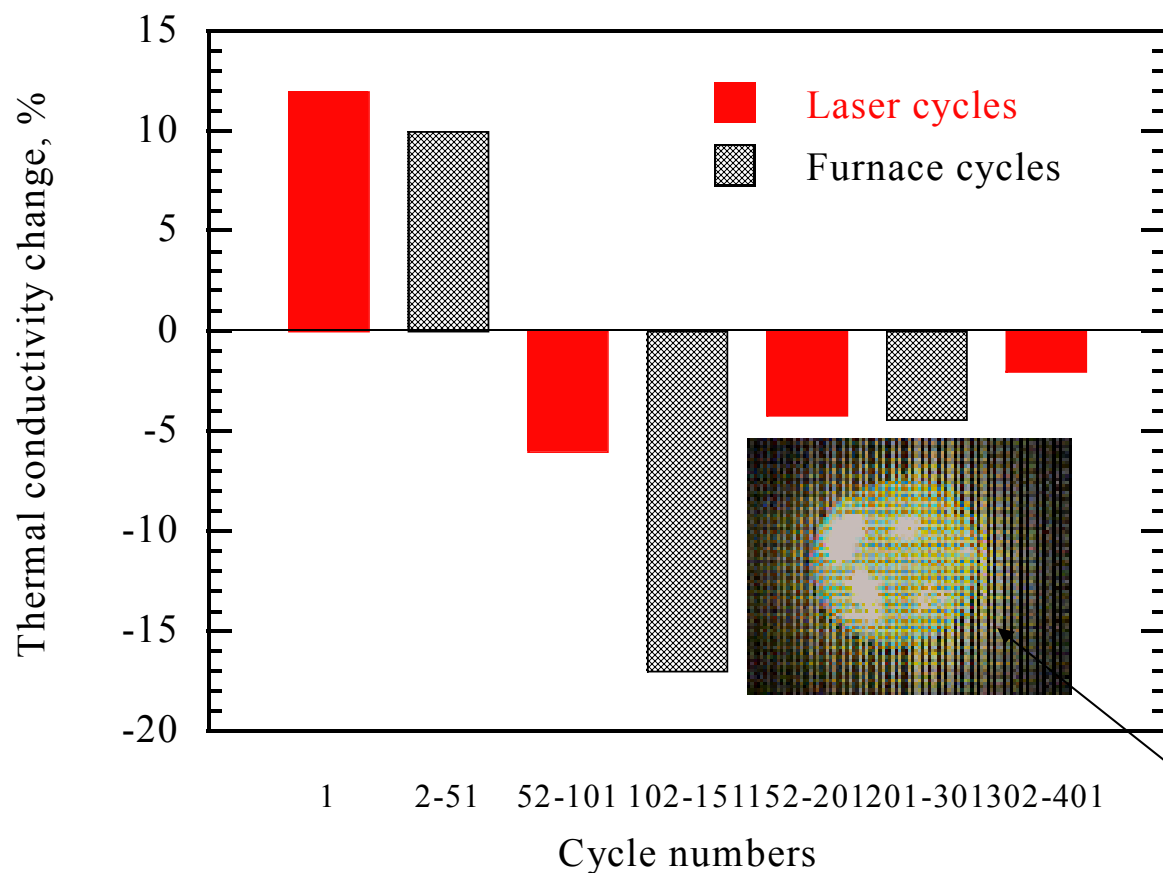
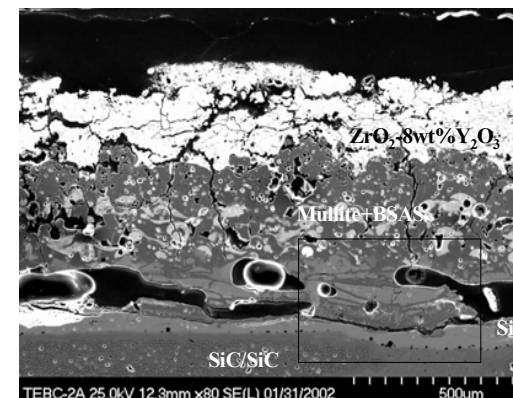
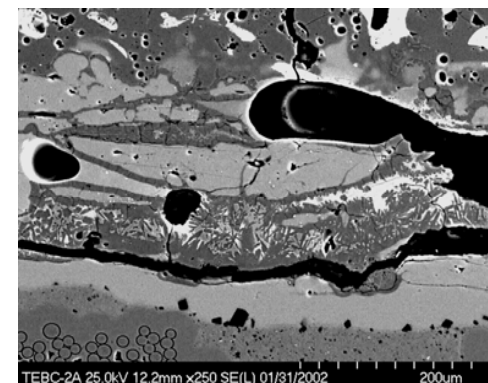
Accelerated Coating Degradation under Thermal Gradients

- Significant interfacial pore and eutectic phase formation due to water vapor attack and Si diffusion at the interface temperature of 1300°C under the thermal gradient cycling conditions

**Coating
spallation**

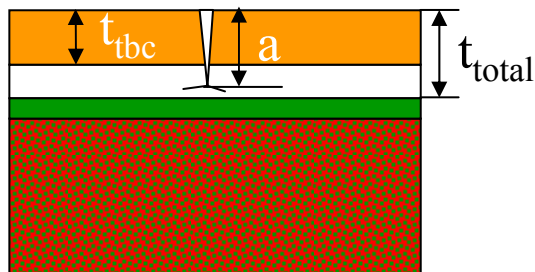
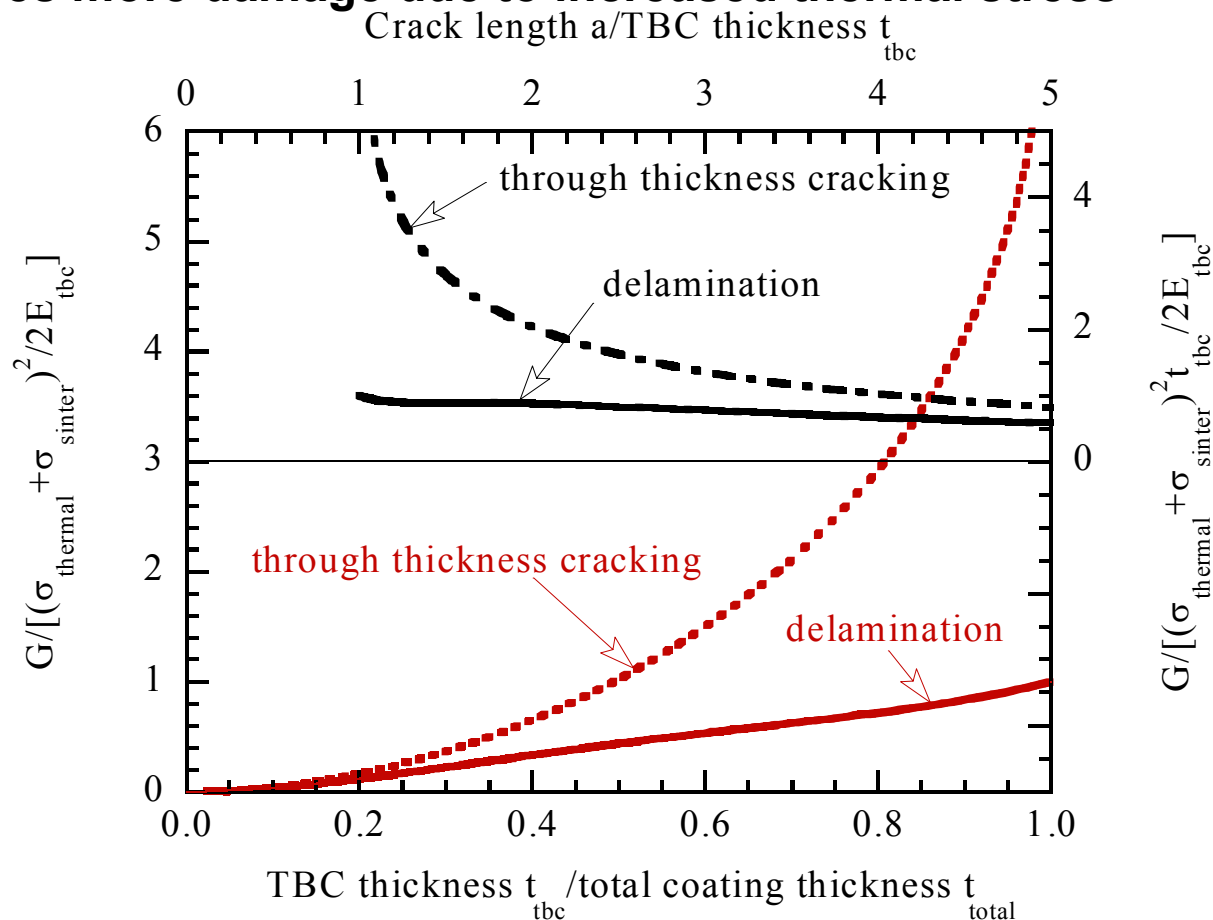
TEBC Delamination Driving Force and Design Issues

- Surface cracking and delamination are facilitated by a thicker TBC
- Low conductivity, sintering resistant, low expansion, and compliant TBCs will lower cracking driving force
- Thermal gradient imposes more damage due to increased thermal stress and sintering
